WL-TR-96-4015

CERAMIC BEARING DEVELOPMENT

VOL 1, FATIGUE AND WEAR BEHAVIOR OF NBD-200  
SILICON NITRIDE BALLS

HAROLD I. BURRIER, JR.  
CHARLES BURK

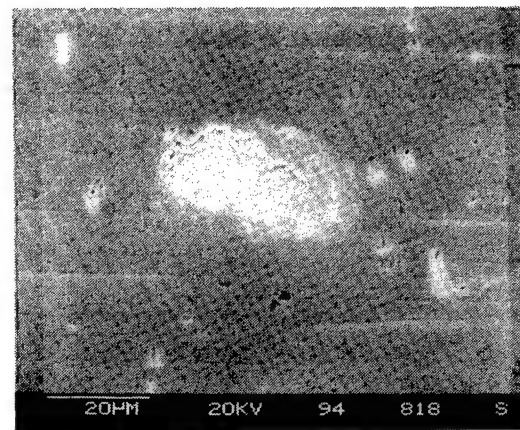
(d)

Figure 56 Post-Test Appearance Of Inner Race Of All-Steel Bearing M-50-X1 Run 500 Hrs. At 2.27 GPa (329 Ksi)  $\lambda = 0.3$  (a) General Appearance (b,c,d) Microspalling.
